# 111297 Samsung XCover Pro Charging Cradle PVT Testing

Prepared By: Mark Lilly

Test Technician  
Gamber-Johnson

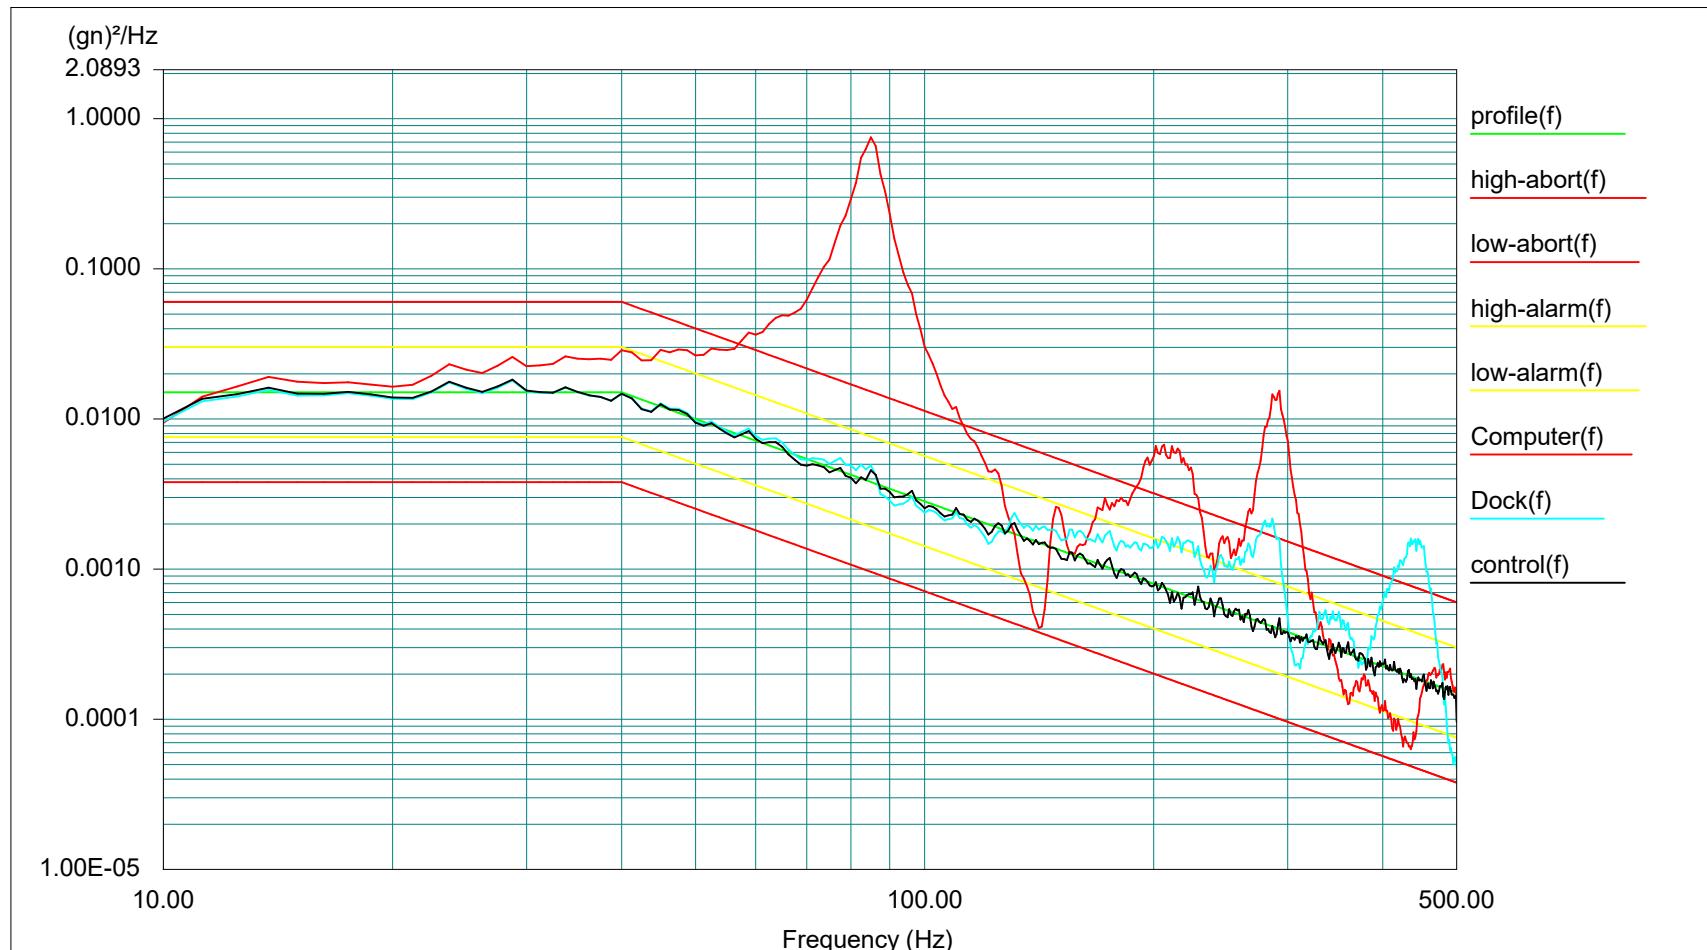
## 111297 Samsung XCover Pro Charging Cradle Operational Vibration Longitudinal Axis

Test Protocol: C1 vertical profile, 1 HR, FTB

Control RMS: 1.040017 gn

Demand RMS: 1.044836 gn

- Battery charged throughout testing.
- There were no issues or concerns.

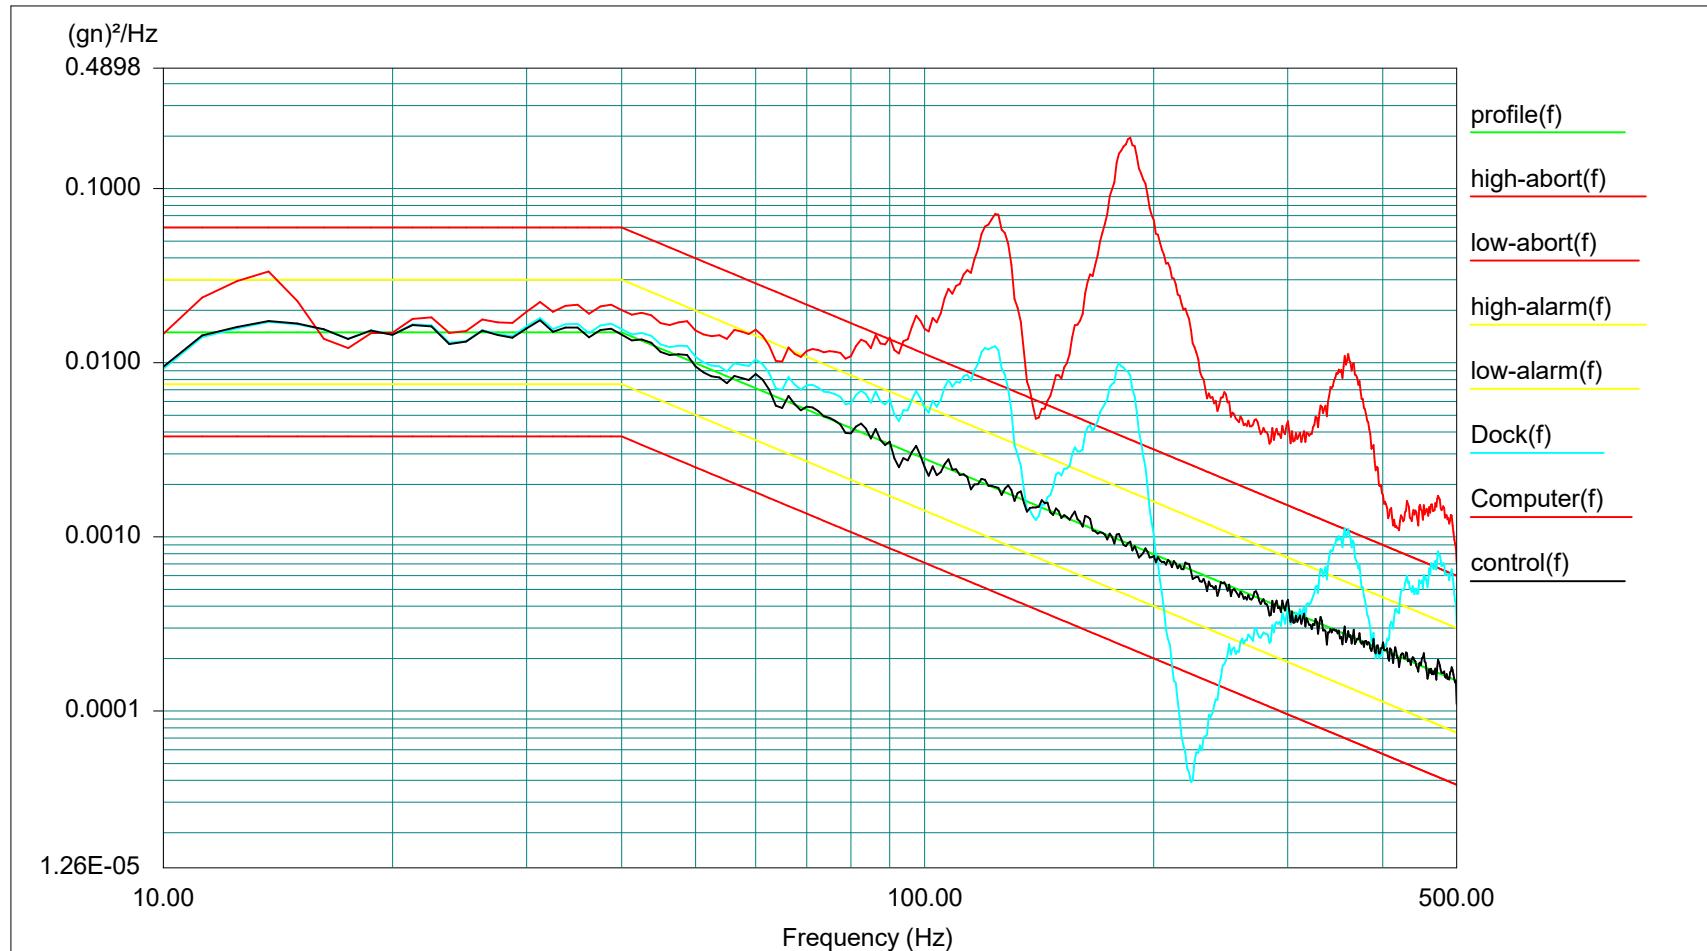
## 111297 Samsung XCover Pro Charging Cradle Operational Vibration Transverse Axis

Test Protocol: C1 vertical profile, 1HR, STS

Control RMS: 1.045747 gn

Demand RMS: 1.044836 gn

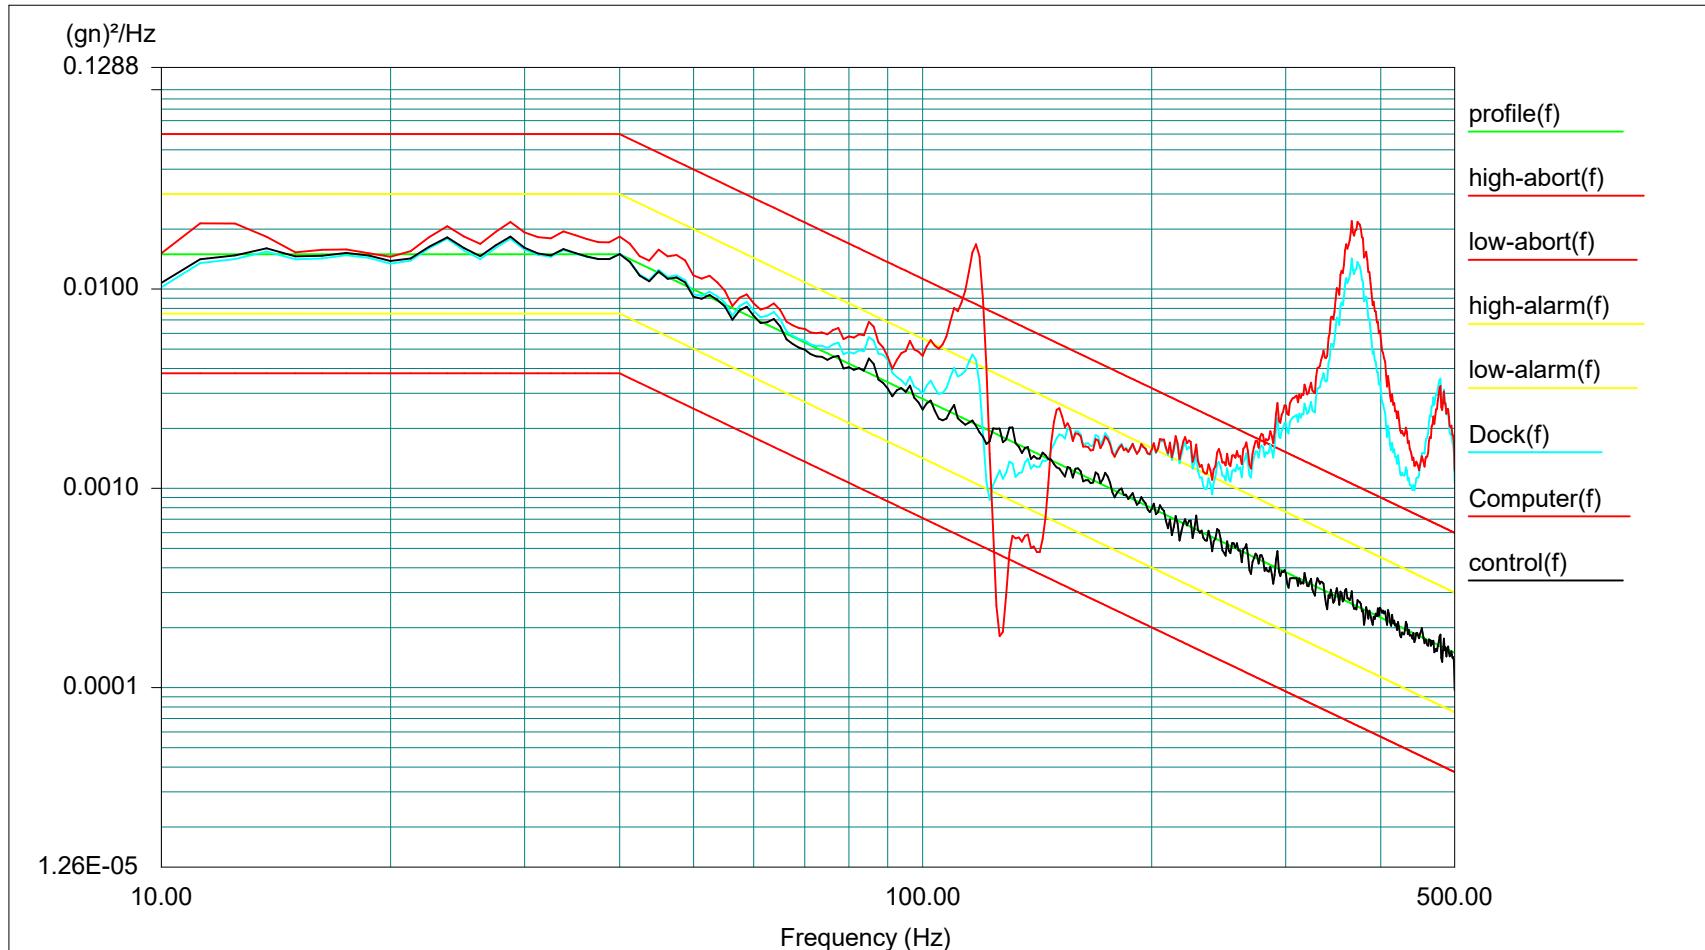
# 111297 Samsung XCover Pro Charging Cradle Operational Vibration Vertical Axis

Test Protocol: C1 vertical profile, 1 HR, Vertical

Control RMS: 1.042880 gn

Demand RMS: 1.044836 gn

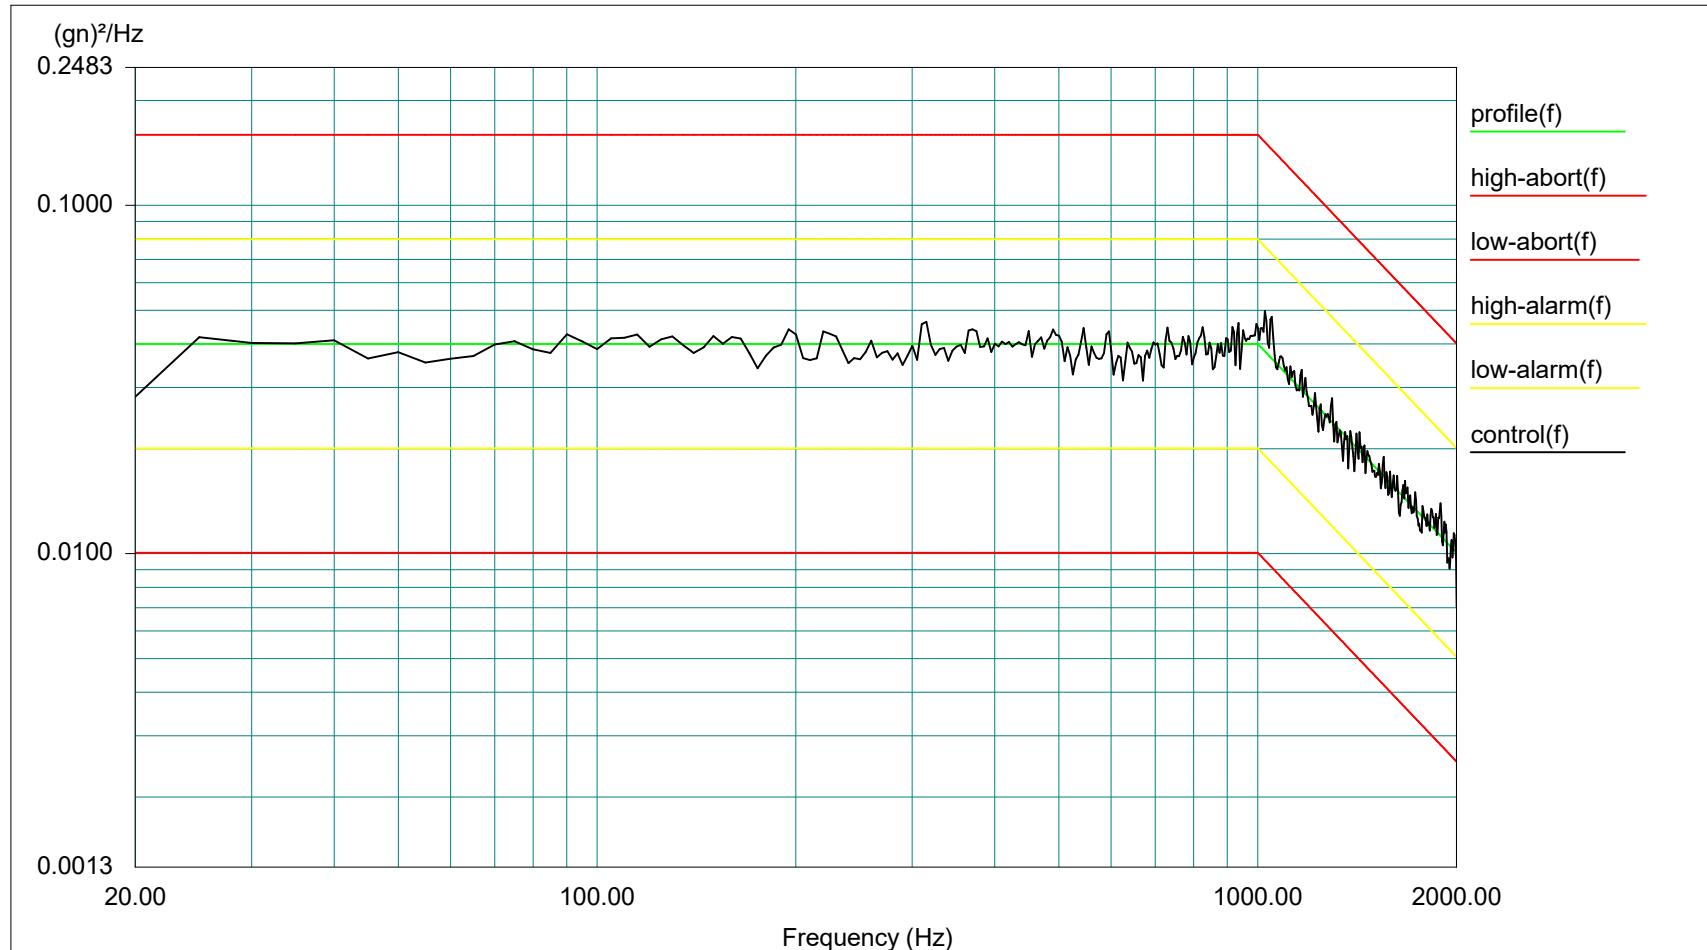
# 111297 Samsung XCover Pro Charging Cradle Non-Operational Vibration All Axes

Test Protocol: MIL-STD-810G E-1, 1 HR, FTB

Control RMS: 7.678018 gn

Demand RMS: 7.701191 gn

- No dust and wear observed.

- The phone and cradle were confirmed fully functional.
- No immediate issues or concerns.

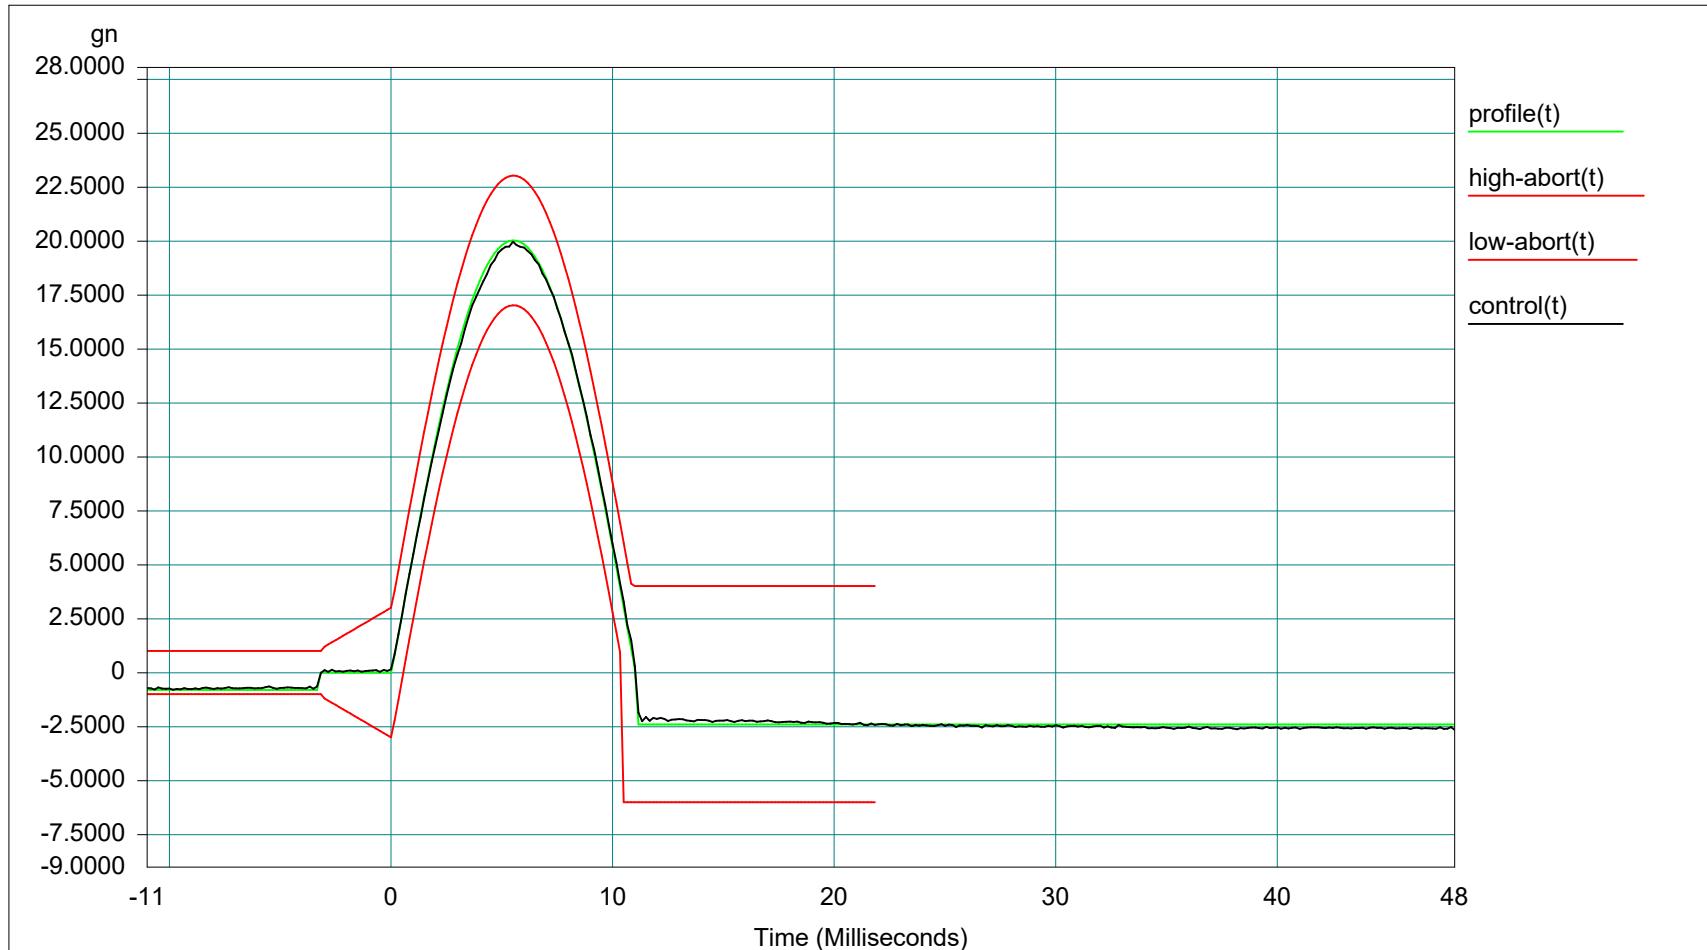
# 111297 Samsung XCover Pro Charging Cradle 20g Shock; Non-Operational All Axes Positive

Test Protocol: 20g 11ms Shock, FTB, Positive

Control Peak: 19.933544

Demand Peak: 20.000000

Pulse Width: 11.000000 ms

- The phone and cradle were confirmed fully functional.
- No issues or concerns in any axes.

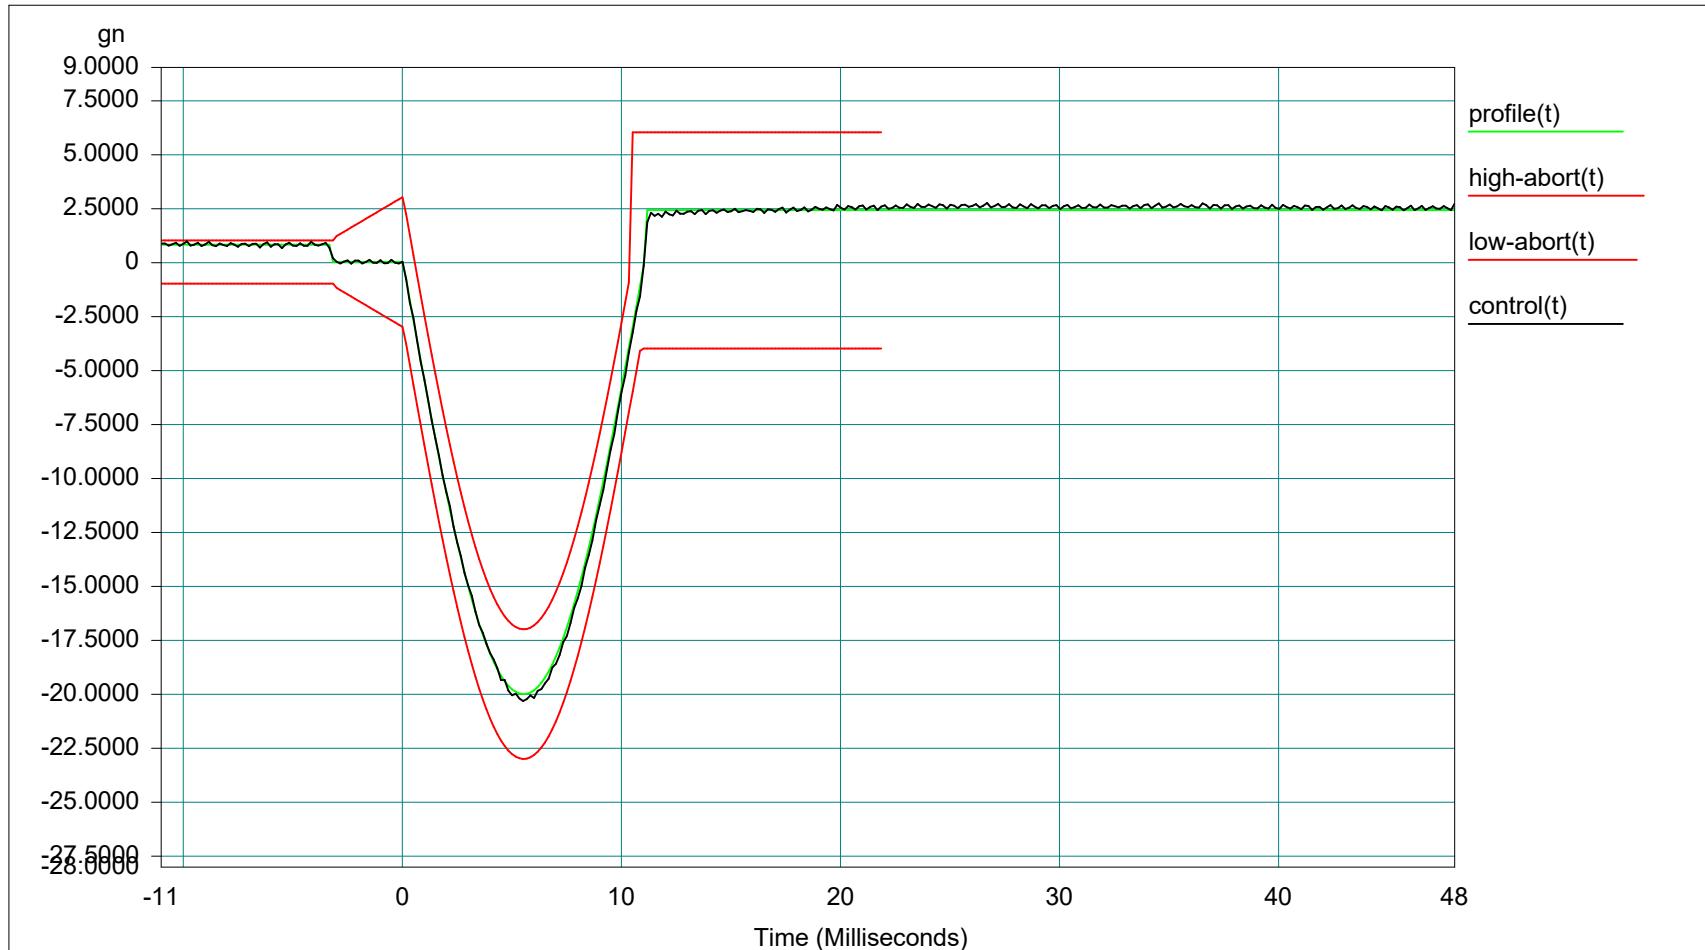
# 111297 Samsung XCover Pro Charging Cradle 20g Shock; Non-Operational All Axes Negative

Test Protocol: 20g 11ms Shock, FTB, Negative

Frame Time: 0.682667 Seconds Control Peak: 20.317886 Control RMS: 2.040299 Full Level Elapsed Pulses: 3

Pulse Type: Half Sine Amplitude: 20.000000 Pulse Width: 11.000000 ms

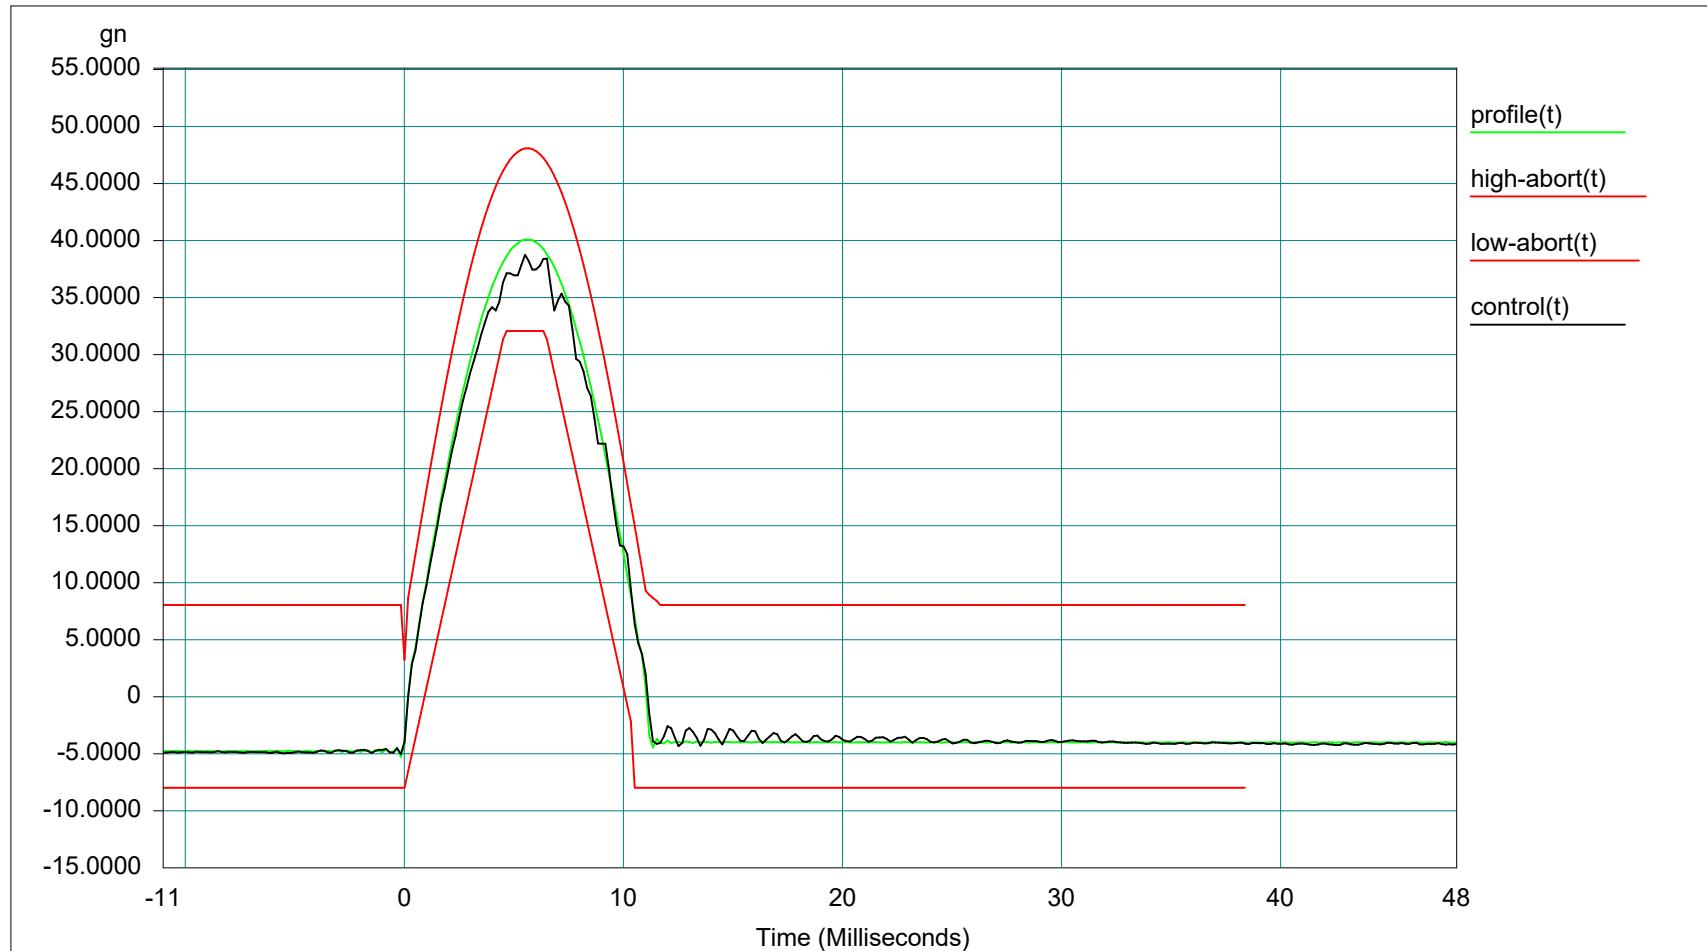
## 111297 Samsung XCover Pro Charging Cradle 40g Shock; Non-Operational All Axes Positive

Test Protocol: 40g 11ms Shock, FTB, Positive

Frame Time: 0.341333 Seconds Control Peak: 38.672234 Control RMS: 5.607409 Full Level Elapsed Pulses: 3

Pulse Type: Half Sine Amplitude: 40.000000 Pulse Width: 11.000000 ms

- There were no projectiles in any axes.
- There were no issues or concerns.
- The phone and cradle were confirmed fully functional.

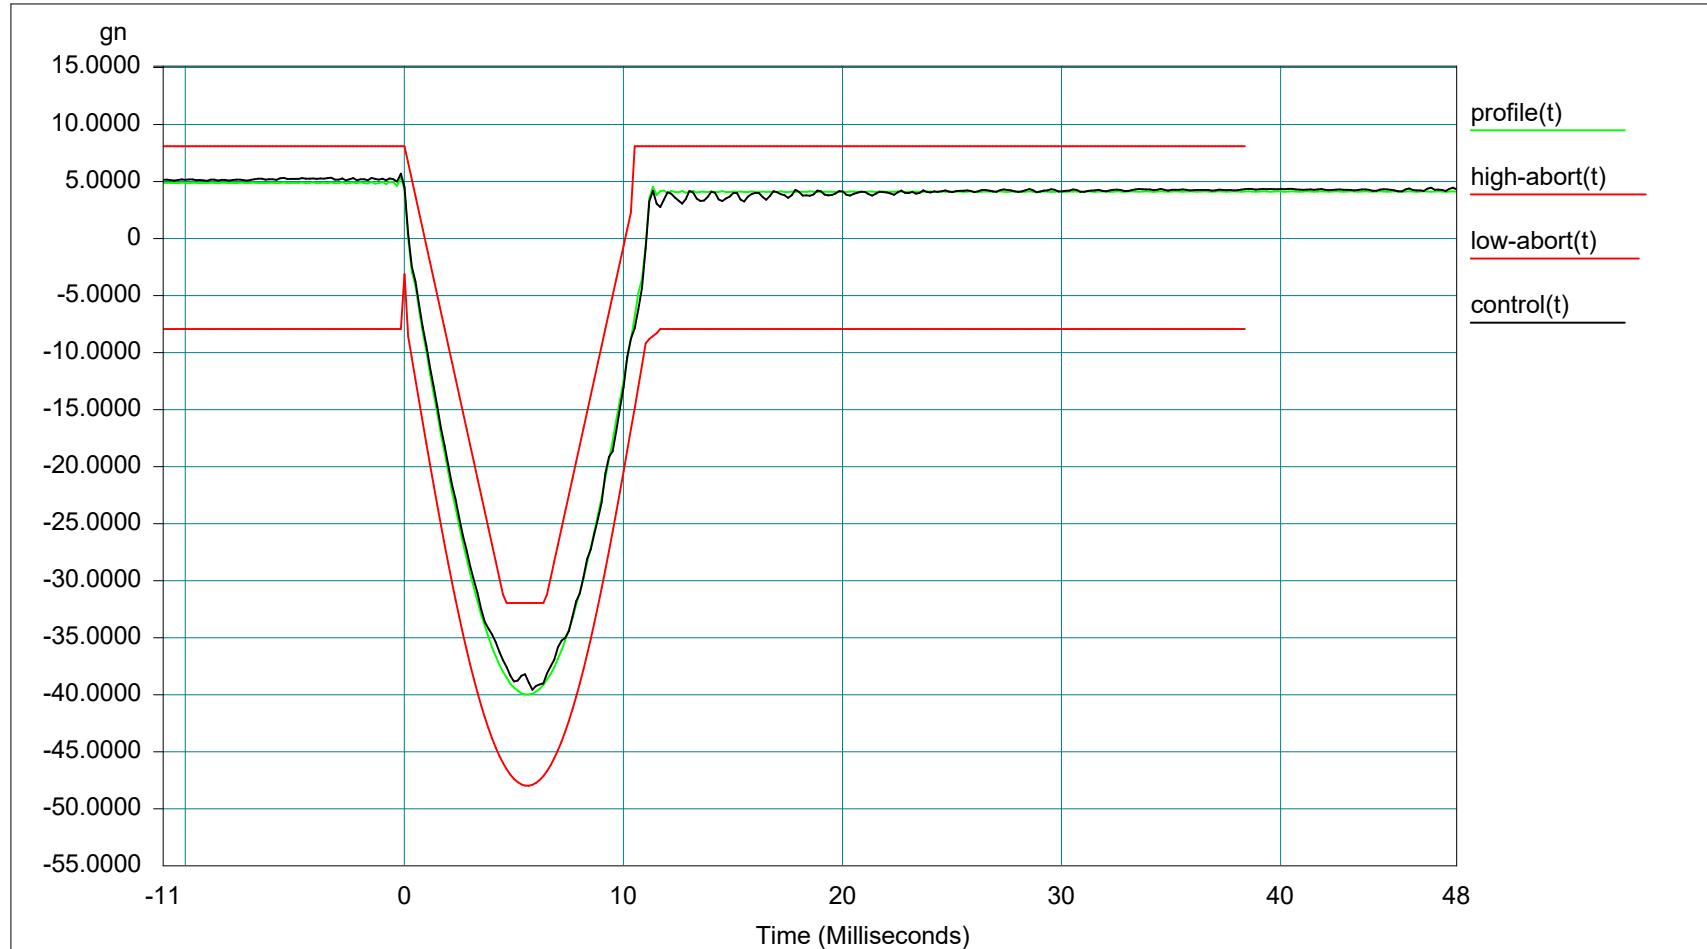
## 111297 Samsung XCover Pro Charging Cradle 40g Shock; Non-Operational All Axes Negative

Test Protocol: 40g 11ms Shock, FTB, Negative

Frame Time: 0.341333 Seconds Control Peak: 39.585728 Control RMS: 5.735403 Full Level Elapsed Pulses: 3

Pulse Type: Half Sine Amplitude: 40.000000 Pulse Width: 11.000000 ms

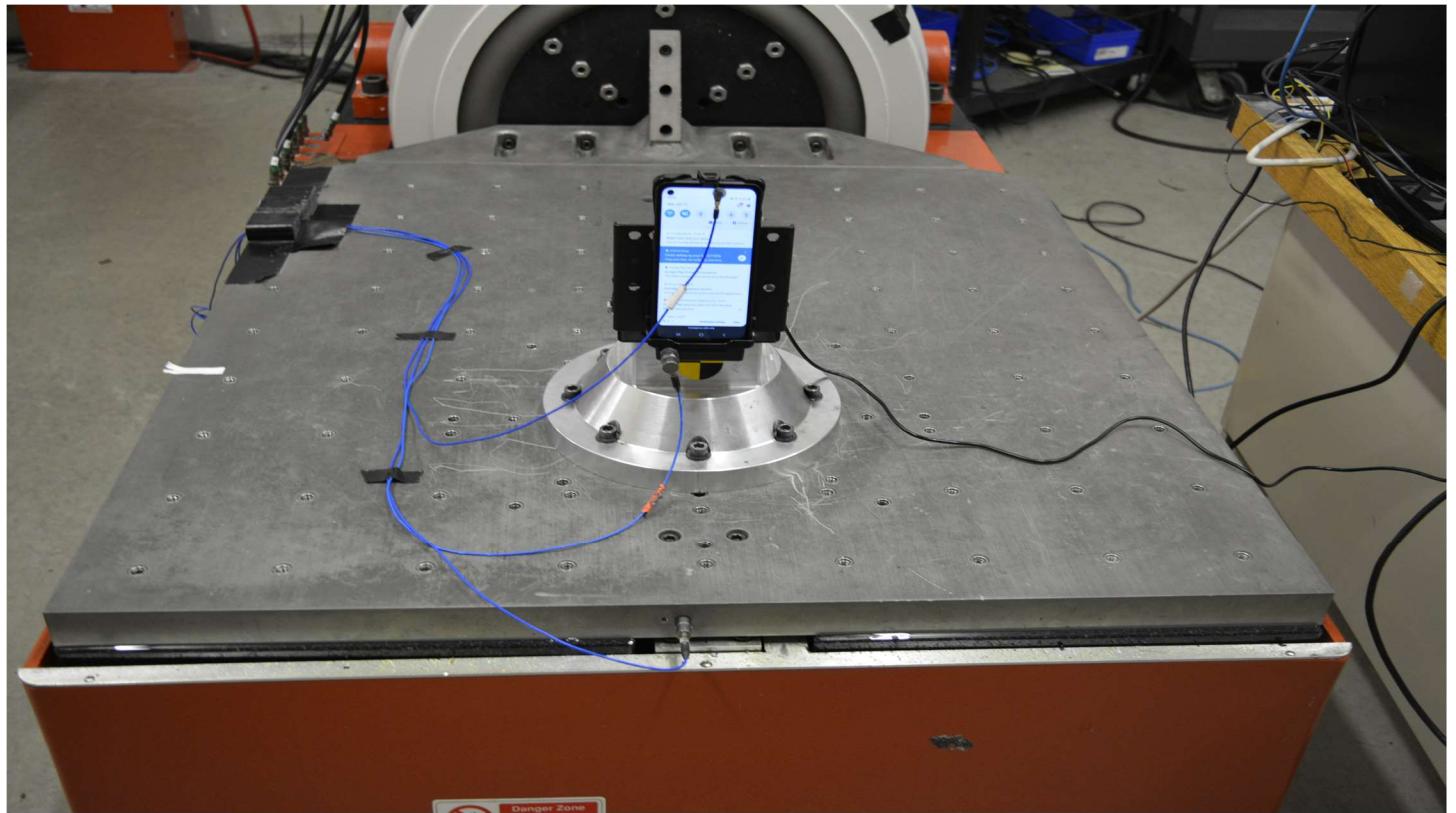
Figure 1: Overall Setup Operational Vibration Longitudinal Axis

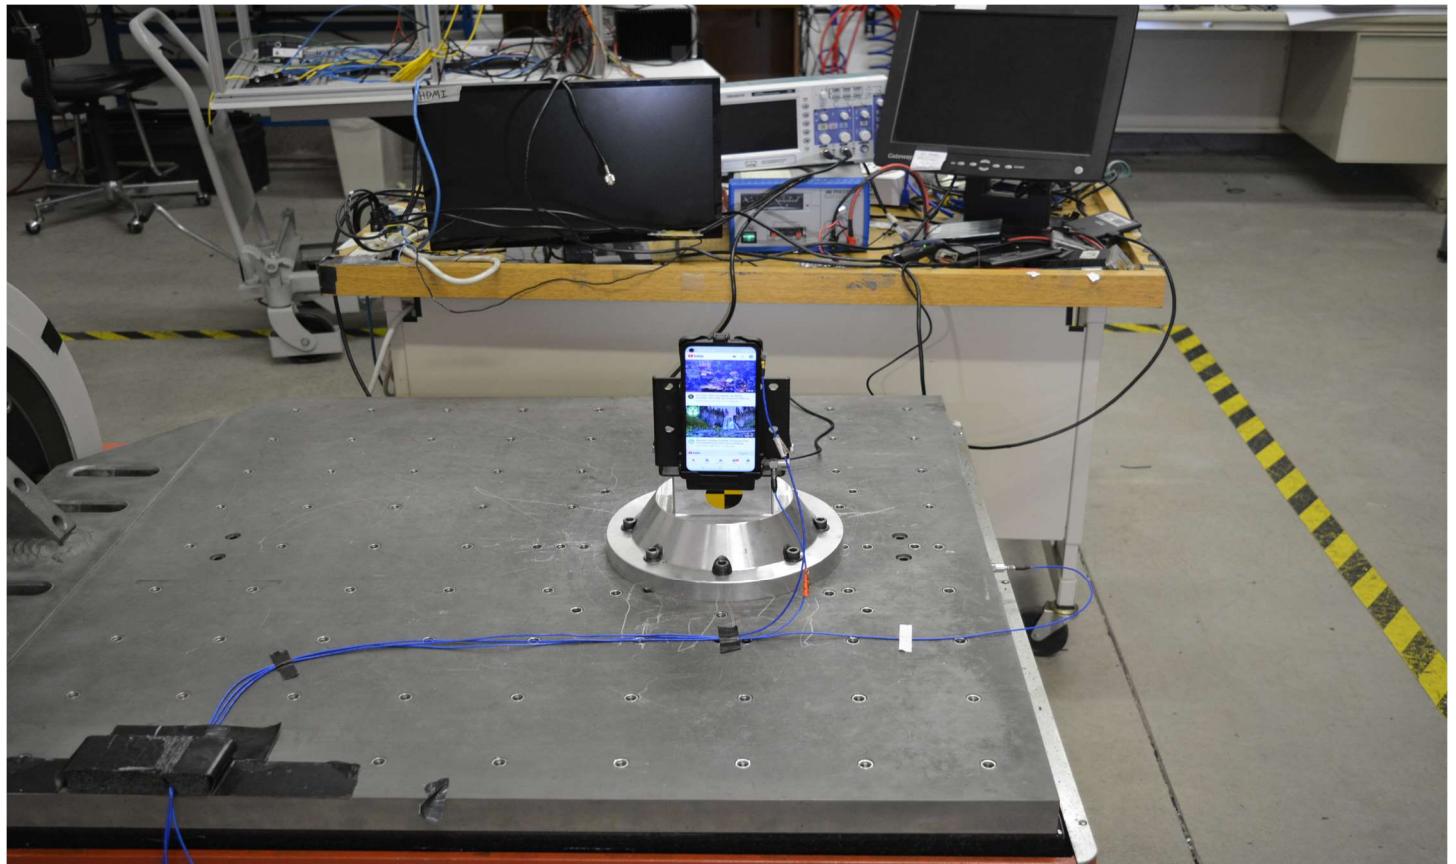
Figure 2: Overall Setup Operational Vibration Transverse Axis

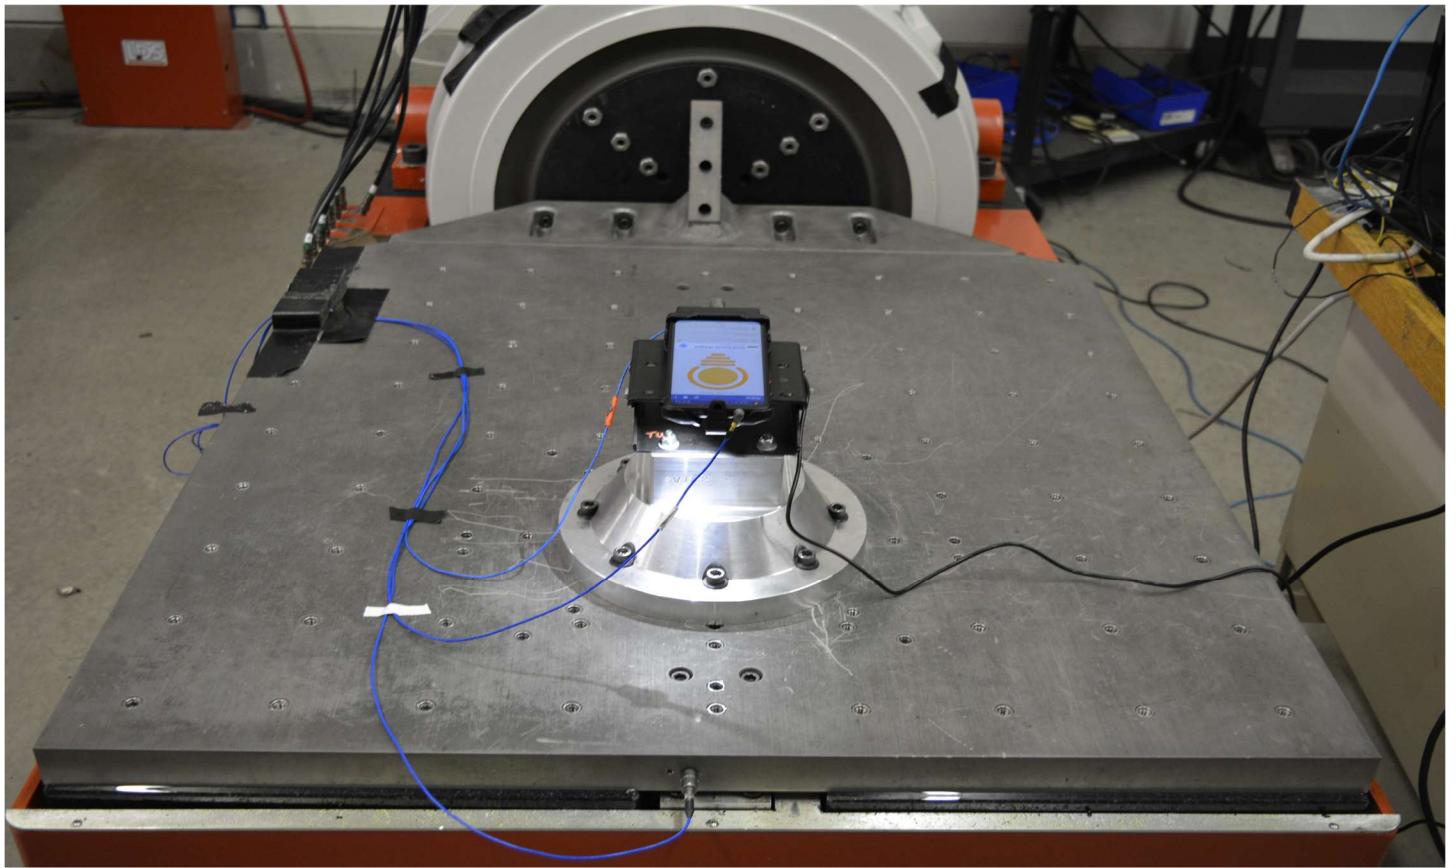
Figure 3: Overall Setup Operational Vibration Vertical Axis

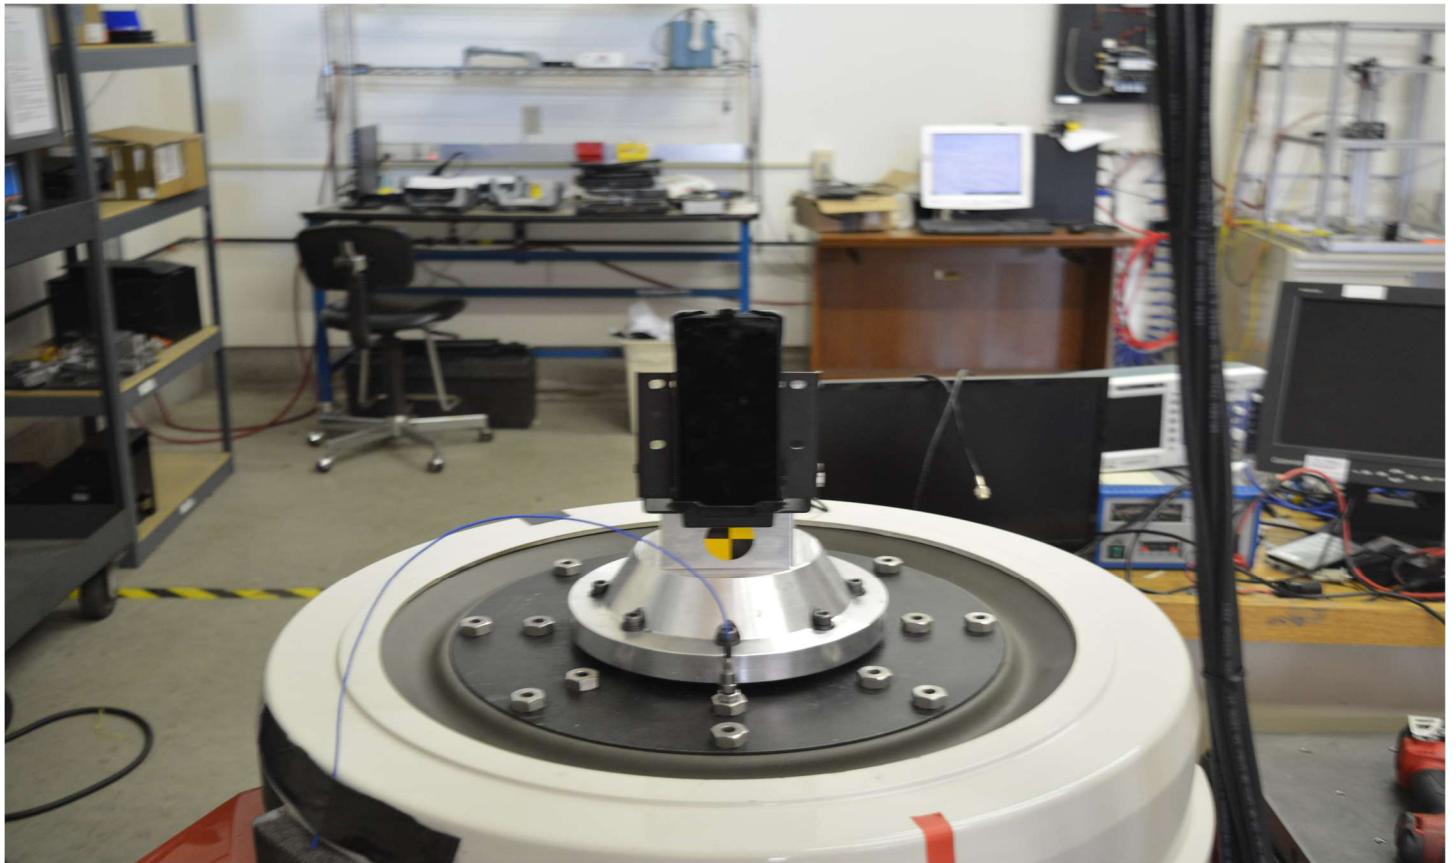
Figure 4: Overall Setup Non-Operational Vibration Vertical Axis

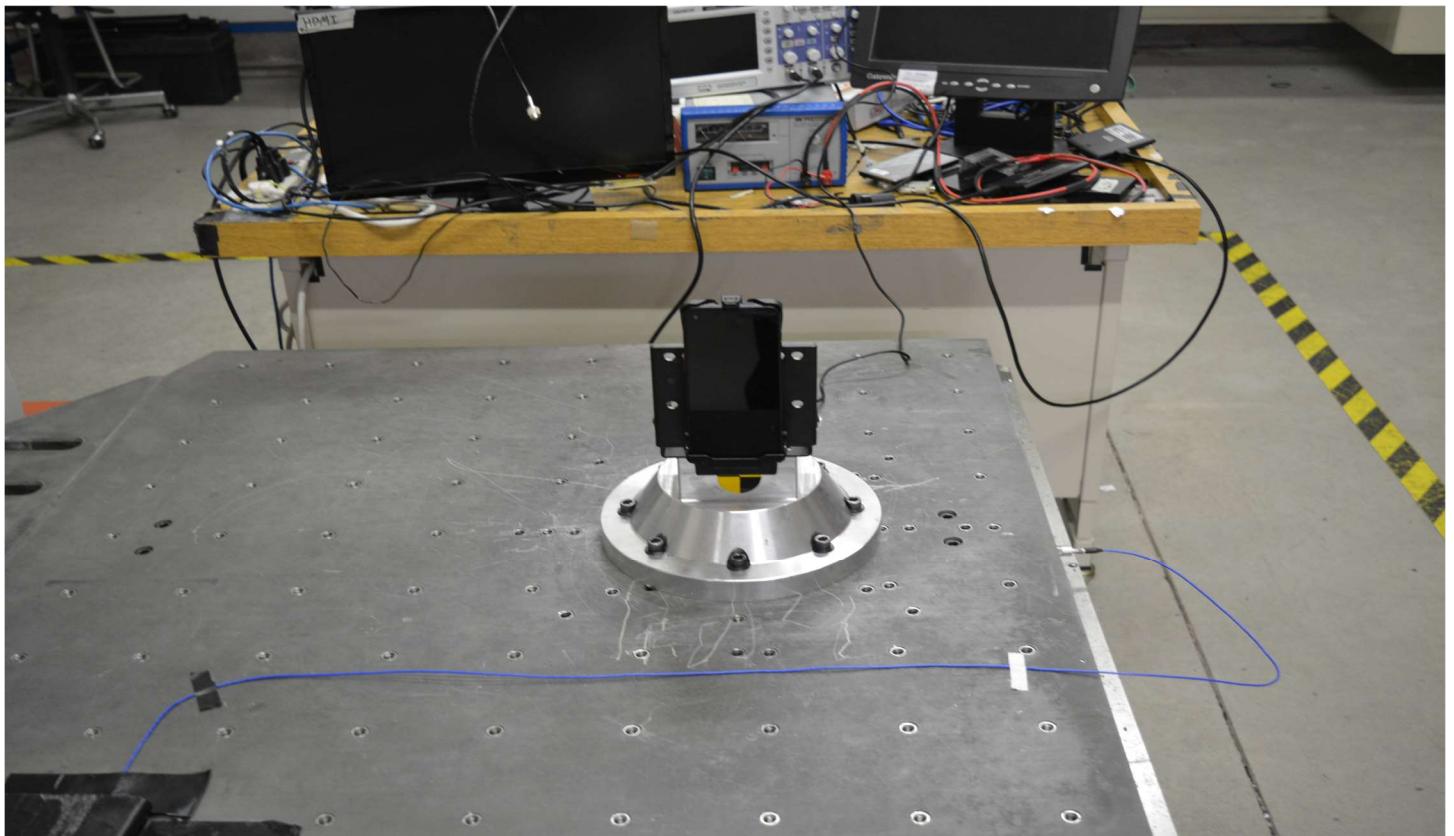
Figure 5: Overall Setup Non-Operational Vibration Transverse Axis

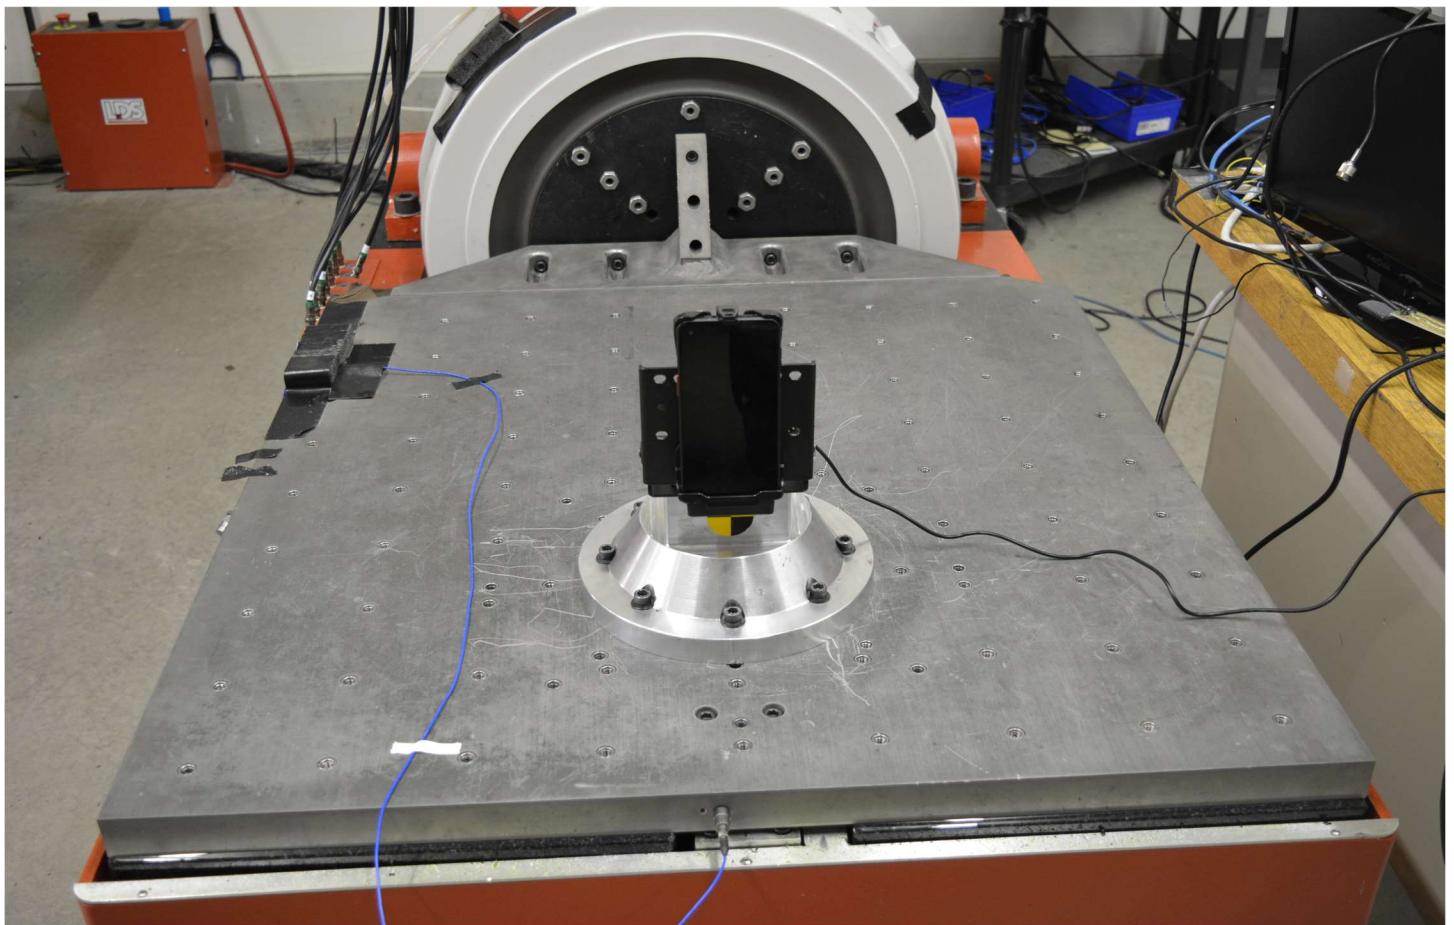
Figure 6: Overall Setup Non-Operational Vibration Longitudinal Axis

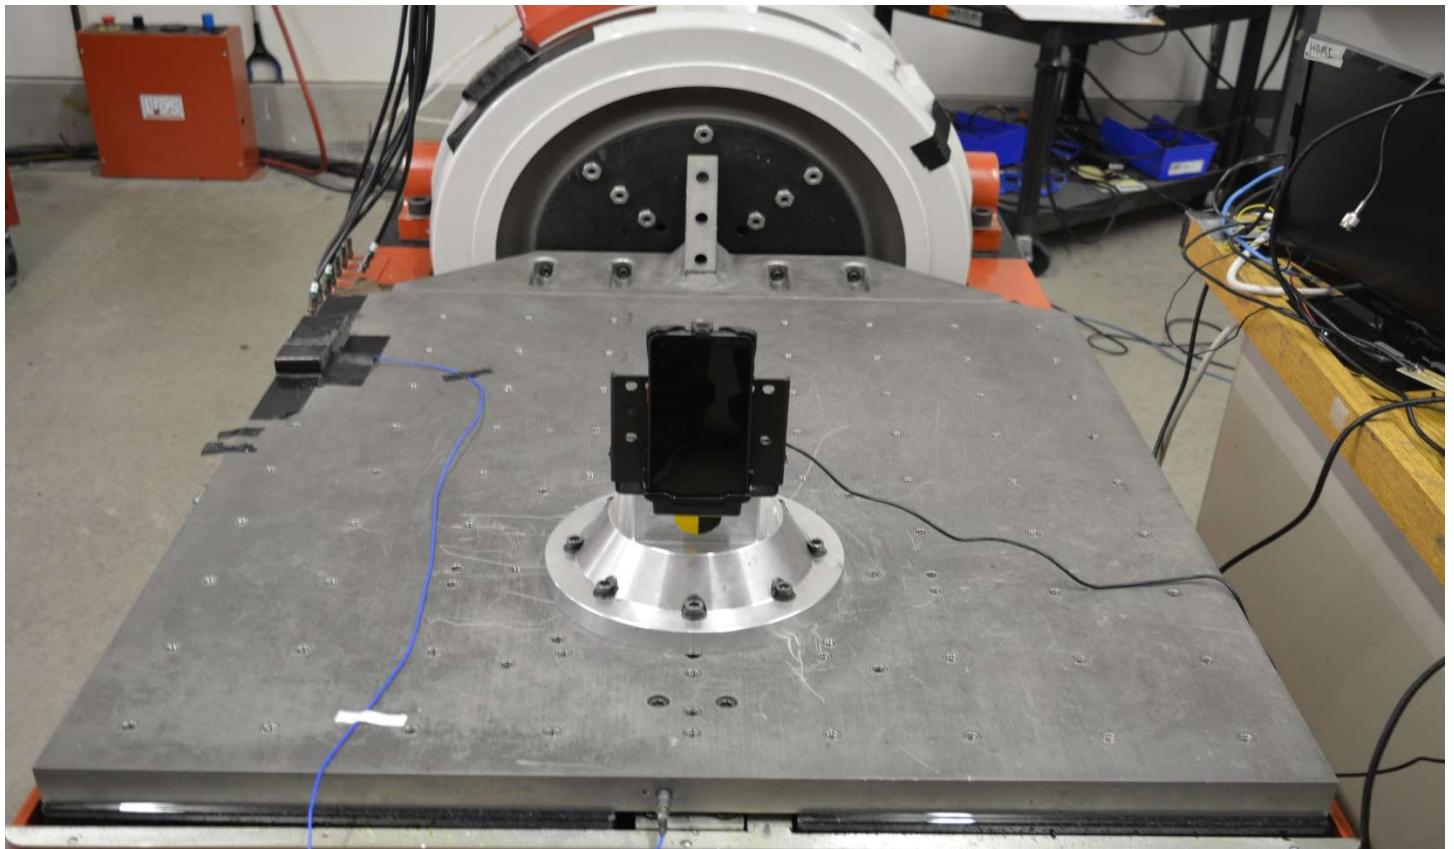
Figure 7: Overall Setup 20g; Shock Non-Operational Longitudinal Axis
