# 111297 Samsung XCover Pro Charging Cradle PVT Testing

Prepared By: Mark Lilly

Test Technician  
Gamber-Johnson

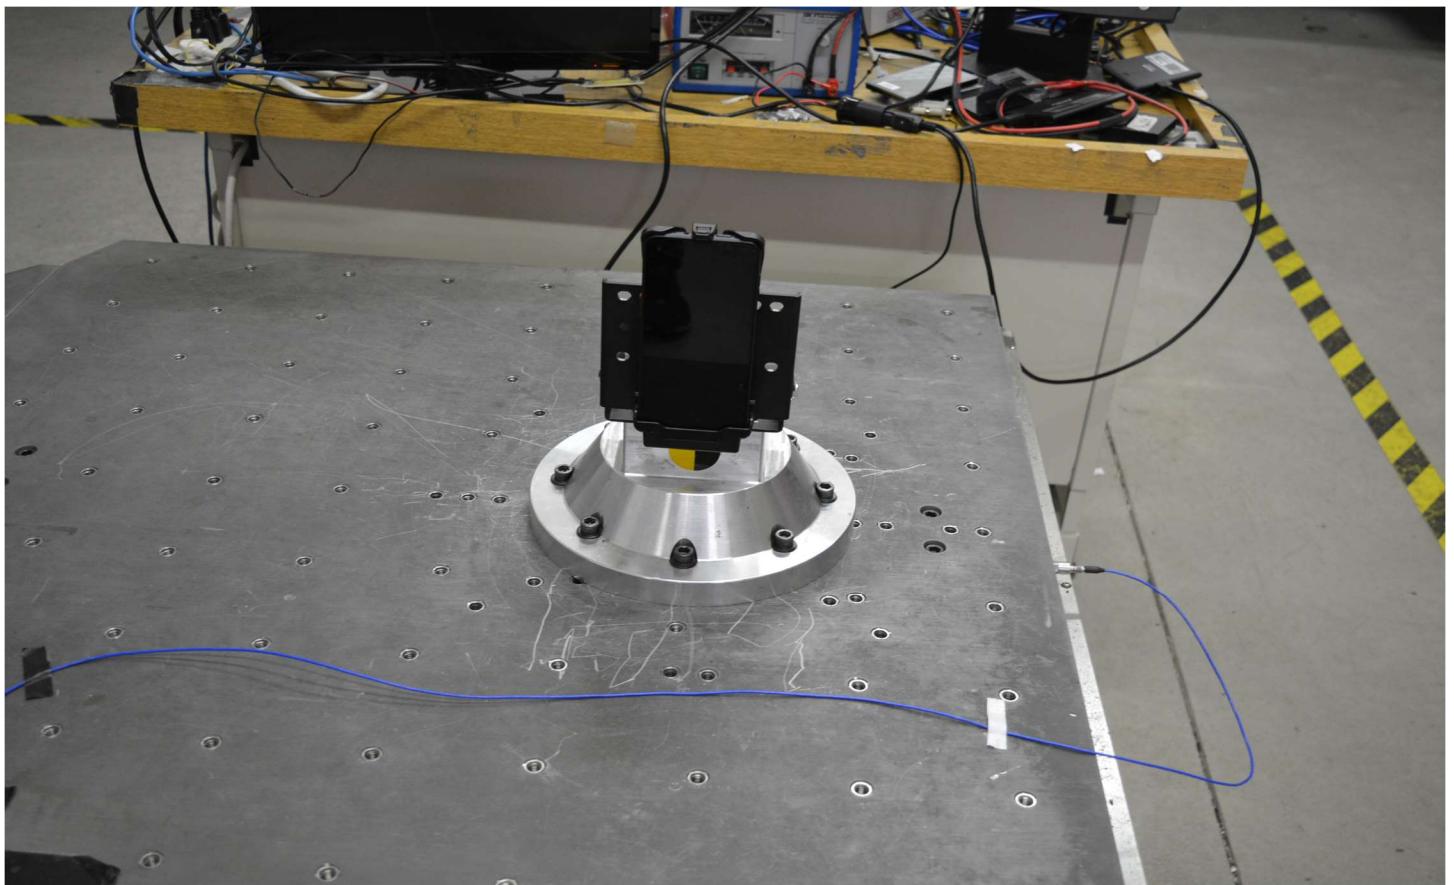
Figure 8: Overall Setup 20g; Shock Non-Operational Transverse Axis

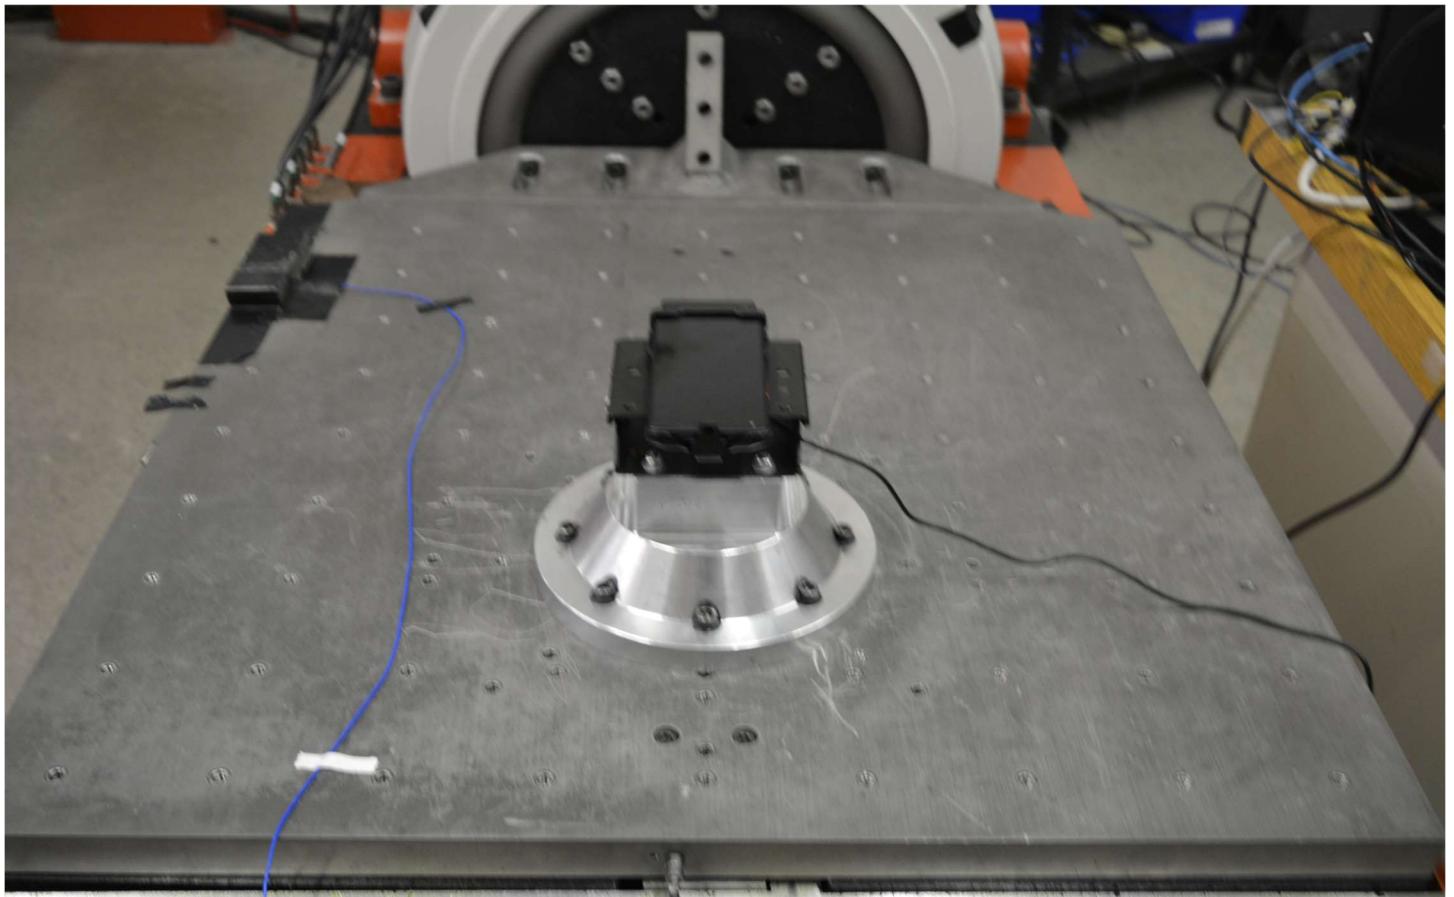
Figure 9: Overall Setup 20g; Shock Non-Operational Vertical Axis

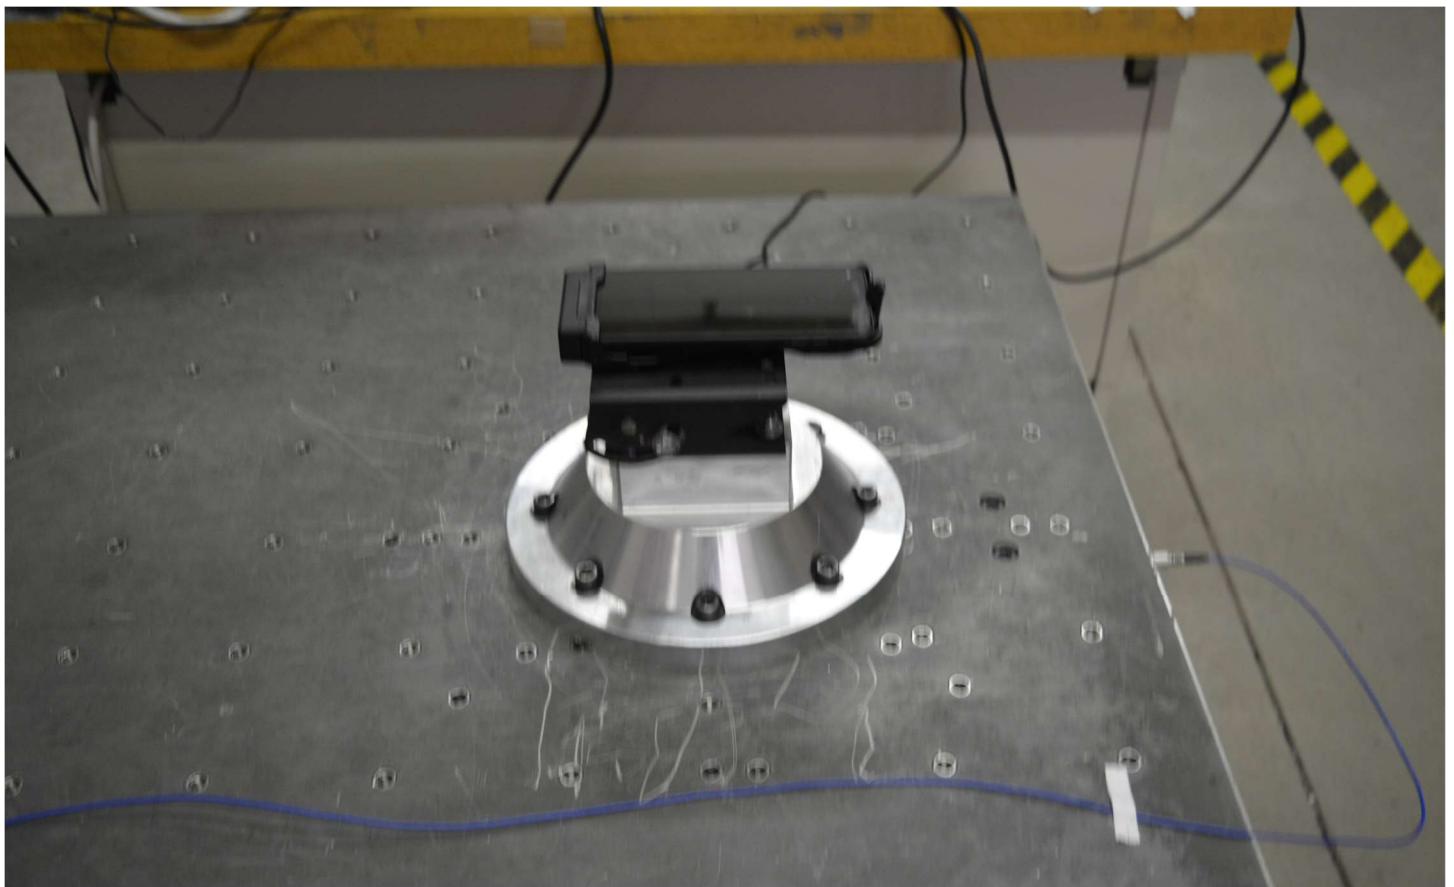
Figure 10: Overall Setup 40g; Shock Non-Operational Vertical Axis

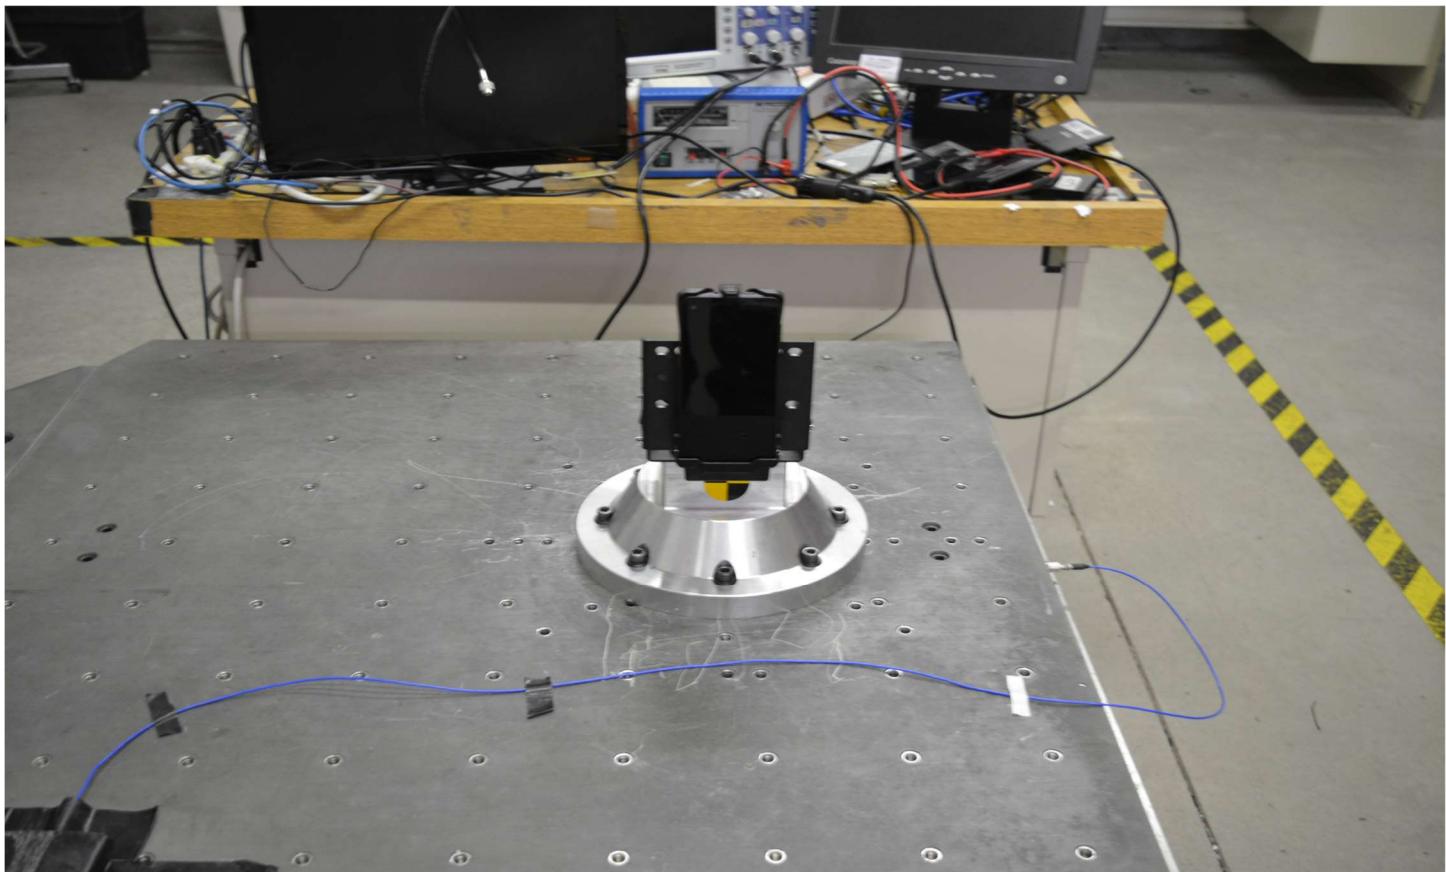
Figure 11: Overall Setup 40g; Shock Non-Operational Transverse Axis

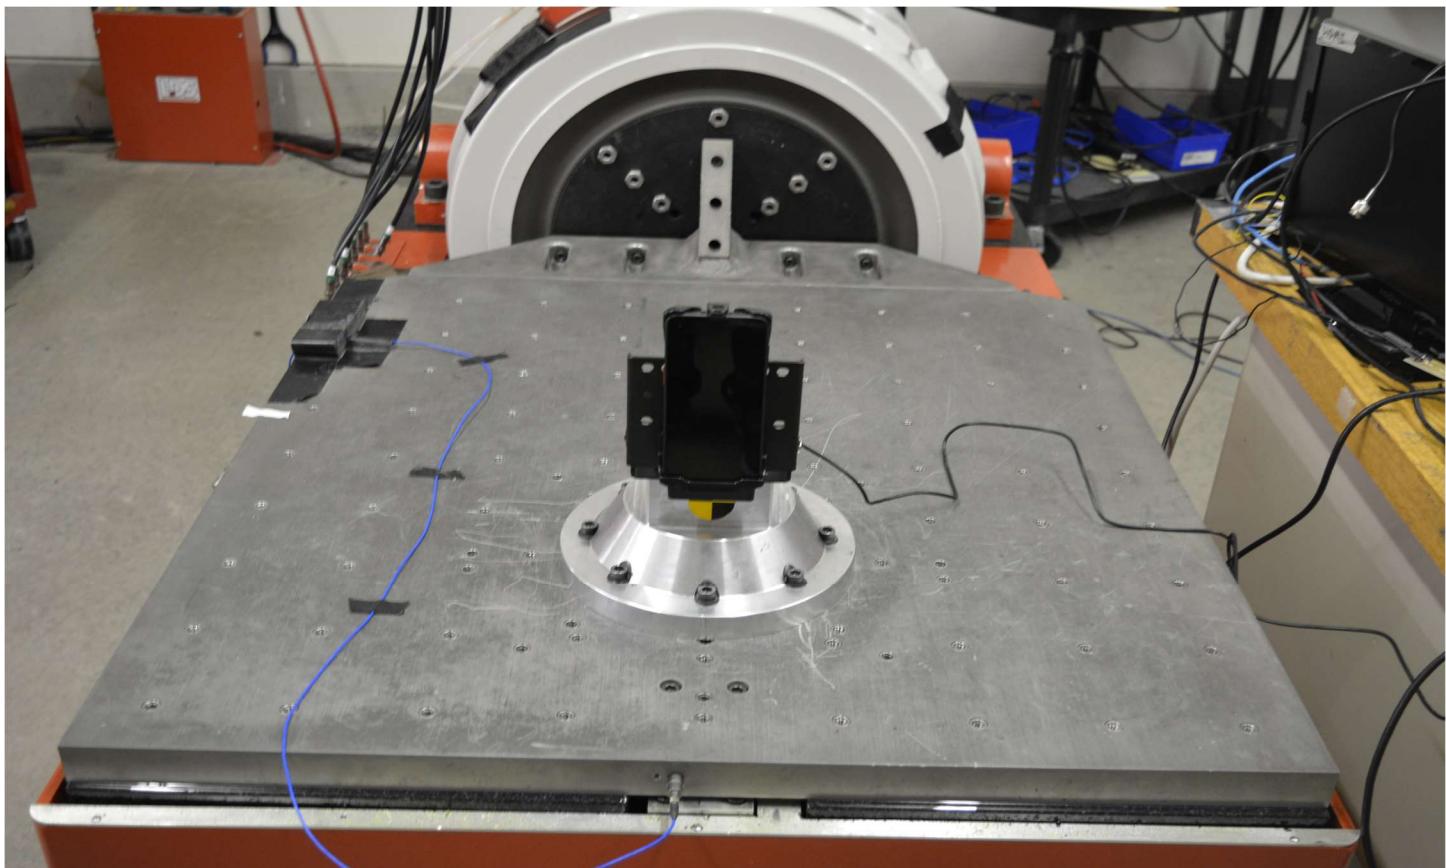
Figure 12: Overall Setup 40g; Shock Non-Operational Longitudinal Axis
